BUILDING-STRUCTURE INVENTORY FORM

1. BUILDING NAME(S) Hartman - Foos House
2. COUNTY: Monroe TOWN/CITY: Greece VILLAGE: ---
3. STREET LOCATION: 543 Mill Road
4. OWNERSHIP: a. public ☐ b. private ☒
5. PRESENT OWNER: Anne M. Foos ADDRESS: (same) Rochester, NY 14626
6. USE: Original: residence Present: residence
7. ACCESSIBILITY TO PUBLIC: Exterior visible from public road: Yes ☒ No ☐
Interior accessible: Explain private residence

Town of Greece Historic Sites Survey
Monroe County, New York
543 Mill Road
page 6

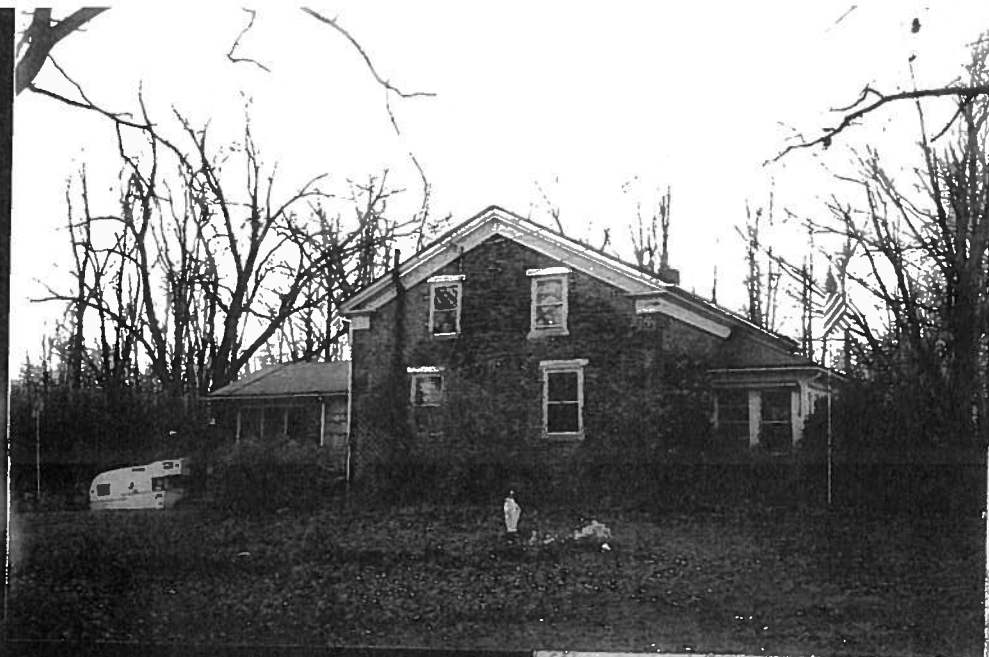
12. PHOTO:

18. One-and-one-half-story, side-gabled, cobblestone farmhouse with a contemporary, one-story, gable-roofed rear (south) wing. The main block, with its side gables, is four-bays-wide by two-bays-deep. The house stands on a fieldstone foundation. Fenestration is regular and symmetrical with 1/1, double hung windows. The windows have stone (probably limestone) lintels and sills. At the southeast, northeast, and northwest corners are Medina sandstone quoins. The southwest corner retains only one (the uppermost) of its quoins; the others have been removed and re-installed on the southwest corner of the adjoining contemporary rear wing.

Under the low-pitched, gabled roof is a wide, Greek Revival style cornice and gable-end returns. The north, south and west elevations are constructed of small cobblestones laid in courses. The east elevation, however, is constructed with cobblestone courses at the gable, south and lower parts of the wall, but has a large, central area constructed with Medina-type sandstone. The explanation for this center section of stone infill has not been determined; it is possible that there was a structural failure that required re-construction of the wall at some time (and they were unable to repair this section with similar cobblestone masonry). There are other areas where repair work is visible

(west end of the facade, next to the quoins). At present, the top part of the west wall appears to be bowing out (note position of the gable window; it is no longer in a completely vertical position.)

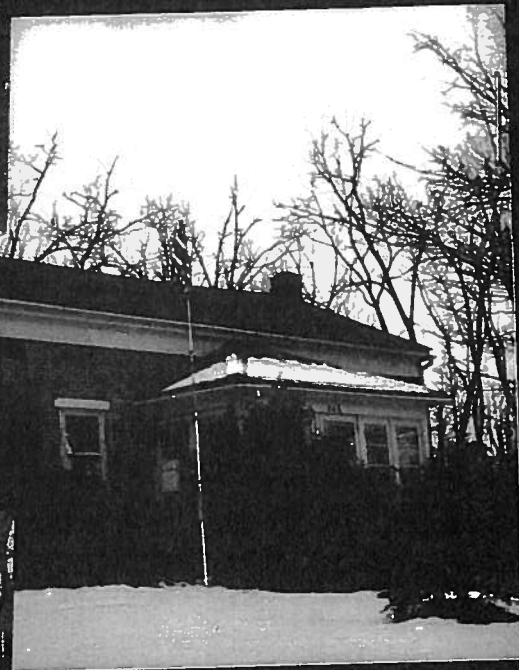
"Here's another cobblestone house. I don't think it's as strong as the others in the town - the modern front porch is a distraction and masks the front of the house. This is a 'red minus' due to the modern porch." P.Malo.
